**FINAL REPORT
MITIGATION OF PCB CONTAMINATION
BUILDING 3
ST LOUIS ARMY AMMUNITION PLANT
ST LOUIS, MISSOURI
(Revision 0)**

**PRE-PLACE REMEDIAL ACTION CONTRACT
CONTRACT NO DACW41-00-D0019
TASK ORDER NO 0002**

October 24, 2003

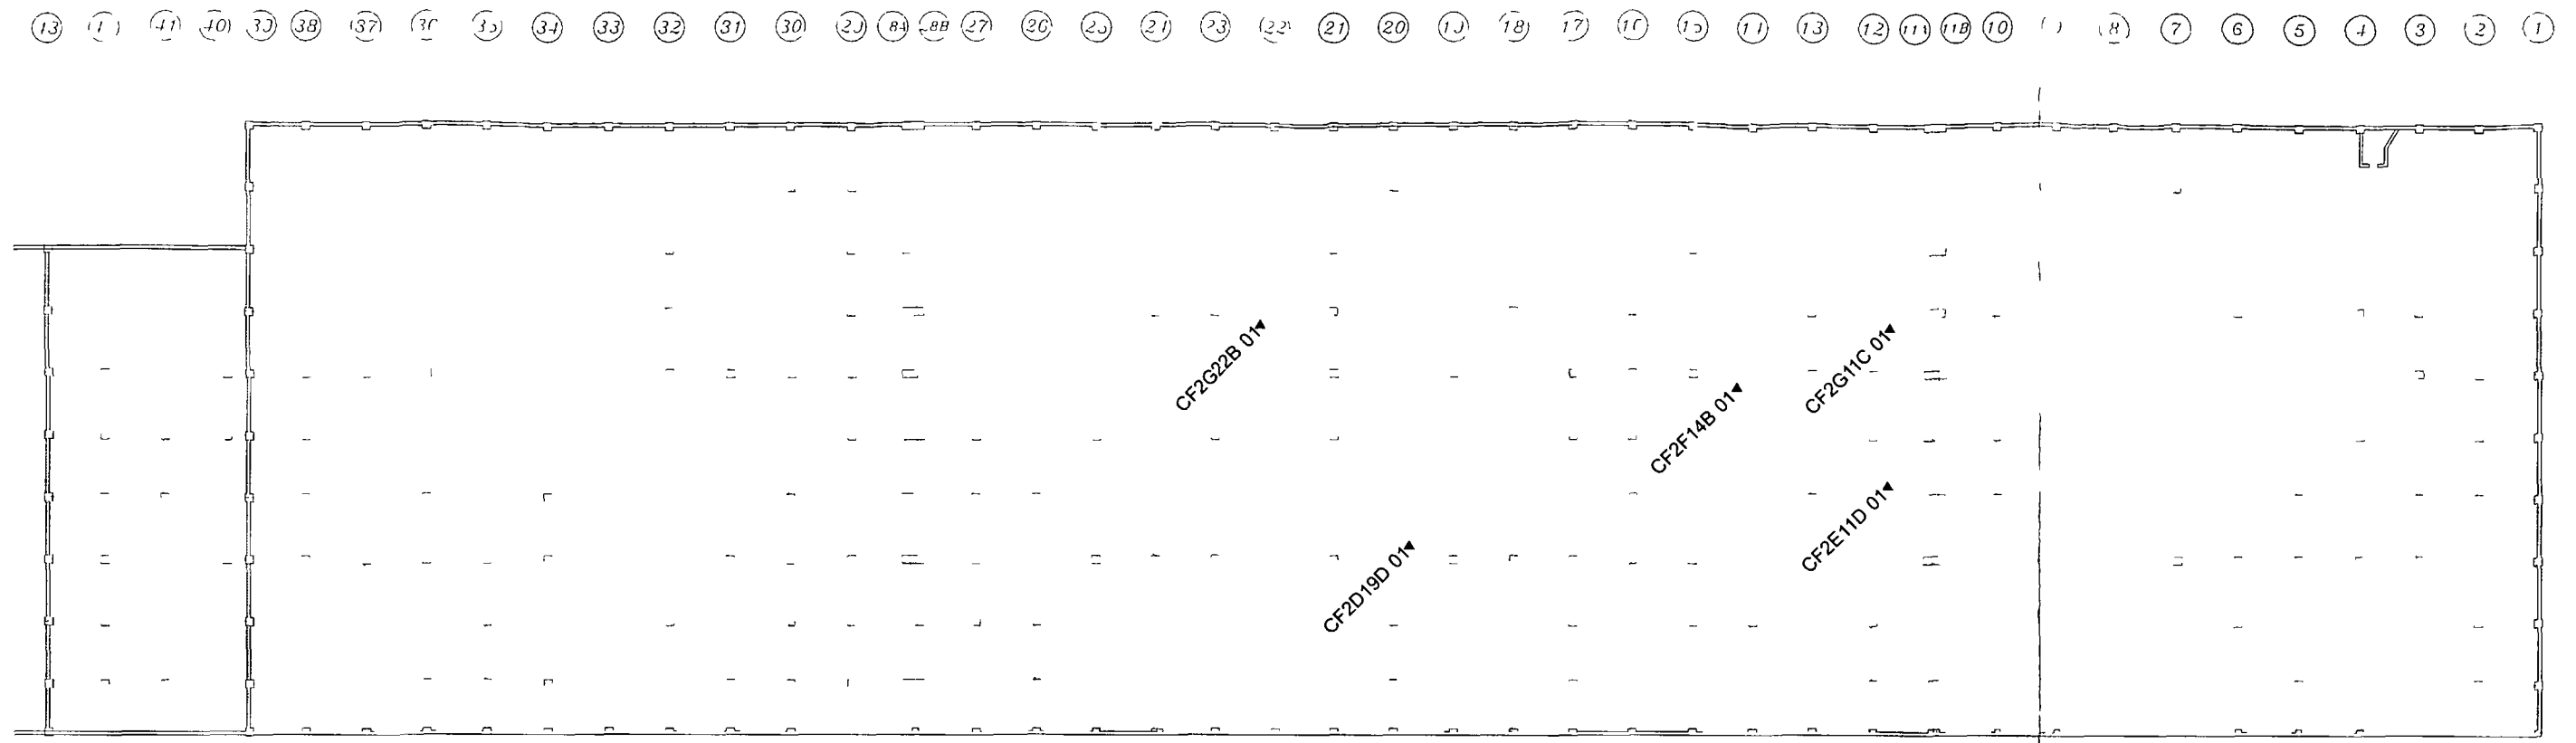
Second Floor Concrete Data Gap Sample Results

Sample ID	Date Collected	Sample Type	Analysis	PCBs Conc. (mg/kg)
CF2D19D-01	11/16/2001	Concrete Floor	PCBs	4.64
CF2E11D-01	11/16/2001	Concrete Floor	PCBs	3.00
CF2F14B-01	11/16/2001	Concrete Floor	PCBs	0.27
CF2F514B-01	11/16/2001	Duplicate of CF1F14B-01	PCBs	0.26
CF2F30-01	7/30/2002	Concrete	PCBs	0.3
CF2G11C-01	11/16/2001	Concrete Floor	PCBs	1.42
CF2G22B-01	11/16/2001	Concrete Floor	PCBs	0.63
